Manhole Inspection Summary

Manhole # S25Q__014MH

Insp Date: **4/9/08 9:40 AM**

Location Address: **1439 W.HAMBURG ST.**

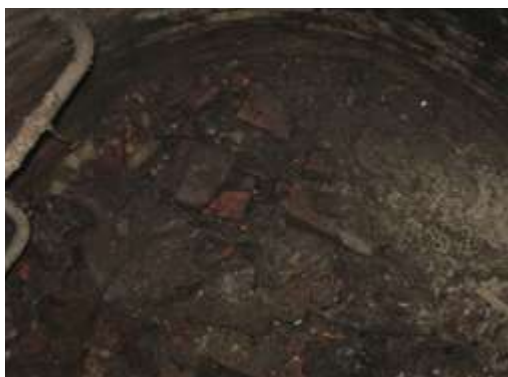
Defect 4

Condition: ☐ Sound ☐ Cracked ☐ Root Intrusion ☐ Deteriorated ☐ Leaks ☒ **Debris**

DEBRIS ON THE BENCH

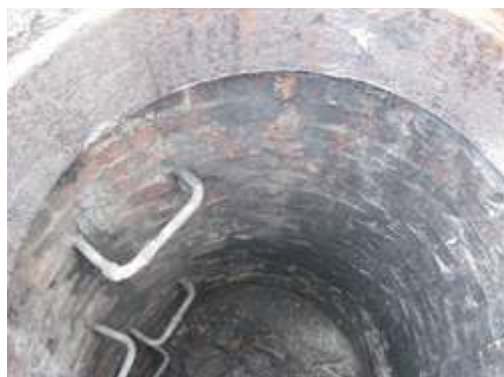
Defect 3

Infiltration: ☐ None ☐ Joint ☐ Cracks ☐ Mortar ☐ Roots ☒ **Wall**

EVIDENCE OF CORBEL AND BARREL INFILTRATION

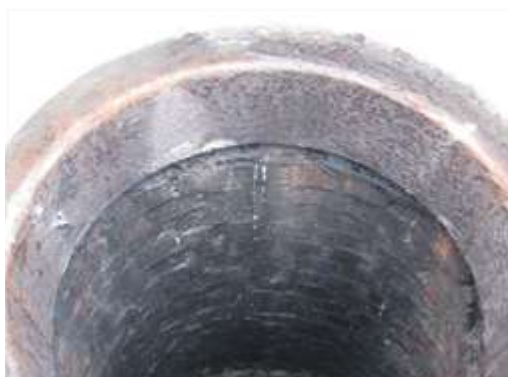
Defect 2

Infiltration: ☐ None ☐ Joint ☐ Cracks ☒ **Mortar** ☐ Roots ☐ Wall

EVIDENCE OF CHIMNEY AND CORBEL INFILTRATION

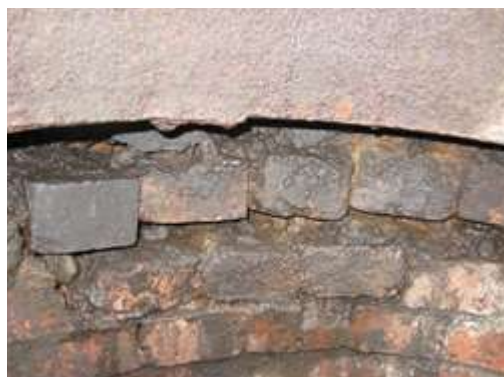
Defect 1

Condition: ☐ Sound ☒ **Cracked** ☐ Root Intrusion ☒ **Loose Brick** ☒ **Deteriorated**

Cracks, Loose Bricks and Dereriation in Chimney, Missing Mortar and Infiltration in Chimney

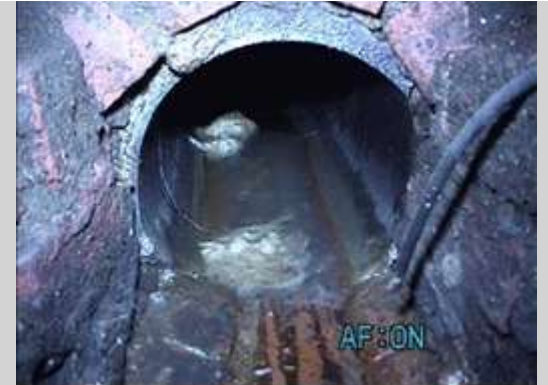
12 O'Clock Outflow

8 in. Circular Gravity Sewer
Pipe Out @ 12 O'Clock

Pipe Height: **8.4** (in.) Rod and Bar (Angled)
Pipe Material: **Clay** ☐ Pipe Lined
Invert Depth: **8.31** (ft.) Flow Characteristics: **Slow**
Deposits: ☒ None ☐ Mud ☐ Sludge ☐ Debris ☐ Grease
Silt Depth: **0** (in.) Deposits Extent:
Infiltration: **None** Pipe Seal Cond: **Sound**

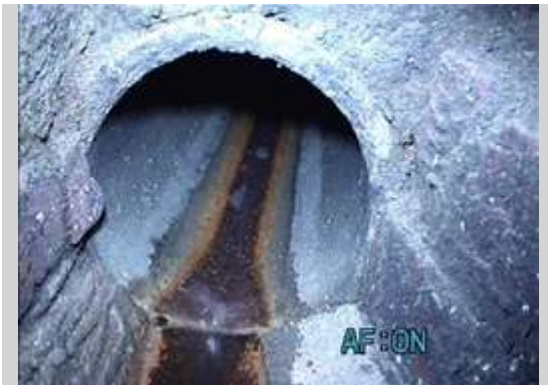
9 O'Clock Inflow

8 in. Circular Gravity Sewer
Pipe In @ 9 O'Clock

Pipe Height: **8.4** (in.) Rod and Bar (Angled)
Pipe Material: **Clay** ☐ Pipe Lined
Invert Depth: **7.84** (ft.) Flow Characteristics: **Slow**
Deposits: ☒ None ☐ Mud ☐ Sludge ☐ Debris ☐ Grease
Silt Depth: **0** (in.) Deposits Extent:
Infiltration: **None** Pipe Seal Cond: **Sound**
